# Listed Buildings at Risk Register Greater Cambridge Shared Planning Service

This report lists all known listed buildings, grade II and above, considered to be at risk from neglect and lack of maintenance, in Greater Cambridge (Cambridge City Council and South Cambridge District Council areas). The listed buildings on this Register have all been assessed against our selection criteria, based on the assessment criteria used by Historic England.

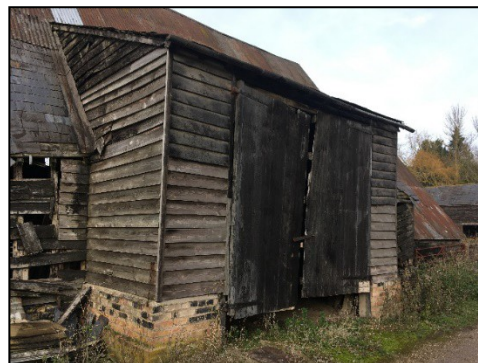
**Map and photograph:**

Partial collapse of aisle/ lean-to  
Missing roof slates – Vulnerability to water ingress and weather

Barn. Late C16, or early C17 with later repairs. Timber-framed and weather boarded, red brick plinth. Corrugated iron roof. Three timber-framed single aisled bays. Double entry facing south-east and single boarded doors to rear lower timber-framed and weather boarded extension to north-east.

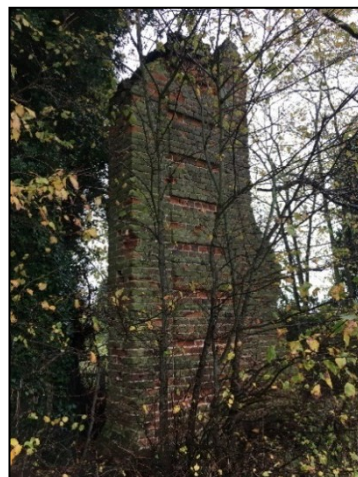
**Map and photograph:**

Overgrown vegetation and trees in close proximity.  
Poor condition of brickwork to capping and loose bricks to piers.

Folly. Circa 1712. Red brick, English bond. Two gate piers with rusticated sides. The only surviving upstanding brickwork associated with the Gamlingay Park built by Sir George Downing.

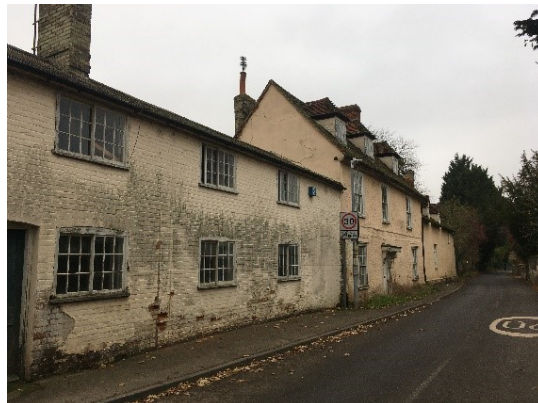
**Map and photograph:**

General lack of maintenance and poor condition of fabric.  
Overgrown vegetation to base of wall and missing plaster with exposed corner post.

House. Early C18 with C19 and later alterations. Timber-framed and plastered; pantiled brick plinth. Red plain tiled roofs. Two storeys with attics, three-unit plan with one storey and attic kitchen range to right hand possibly with an original cross passage, extended in C19 with service rooms.

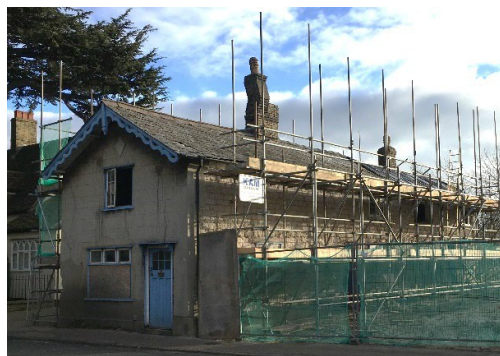
**Map and photograph:**

Missing render to side elevations and exposed clay bat wall  
Missing slates and holes to roof  
Damaged first floor window vulnerable to water ingress and vandalism

House. c.1840. Clay bat, rendered and slate roof with bargeboarded gable end to the road. Two gault brick stacks. Two storeys. Gable end has c.1920 casements, but the side elevation has the original fenestration of three flush frame casements at first floor and three at ground floor. During part of the C19 the house was the Elm Tree P.H..

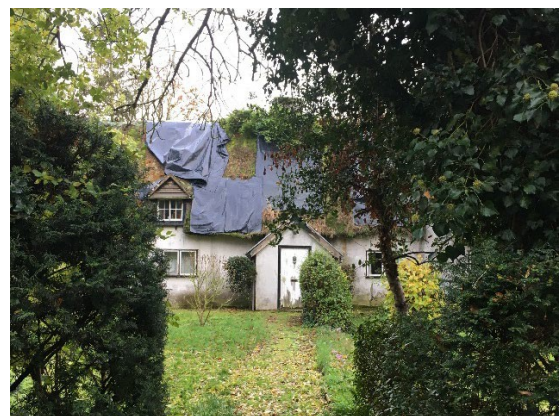
#### **Map and photograph:**

General lack of maintenance and poor condition of fabric.  
Thatch roof in very poor condition.  
Tree growing from chimney/ ridge.

Cottage, probably c.1700. Timber framed, plaster rendered with long straw thatch. Original ridge stack and two C19 end stacks. Single range plan, with lobby entry. One storey and attics. Two gable dormers, C20, and four C20 casements possibly in site of original on either side of doorway to lobby entry.

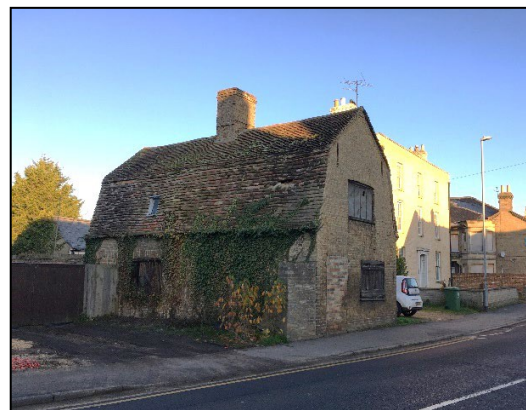
**Map and photograph:**

Overgrown vegetation to walls and roof.  
Slipped roof tiles.

Cottage with shop. Probably late C18/early C19. Local gault brick with plain-tiled mansard roof with original ridge stack. Gable end to road. One storey and attic. Gable end has two windows, the lower boarded, the upper mesh covered, and a doorway, blocked, probably to a former shop.

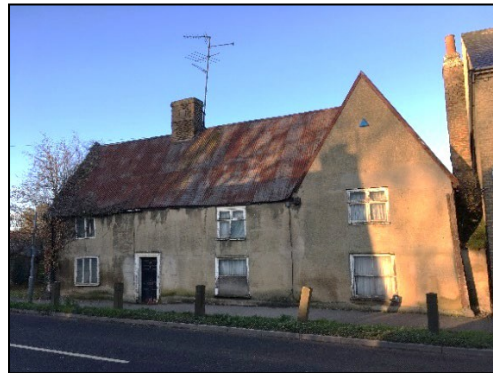
### Map and photograph:

General lack of maintenance and vulnerability to water ingress

House, 1664. Timber framed, stuccoed and incised in imitation of stone, brick rendered to left hand gable end. Corrugated iron roof to original steeply pitched rafters, with axial ridge stack of red brick. Recessed date panel to base of stack with date 1664 recut in render. Plan of main range of lobby entry type with crosswing to right hand.
