WILLINGHAM

CONSERVATION AREA APPRAISAL

Published by
South Cambridgeshire District Council

©08/09/1999

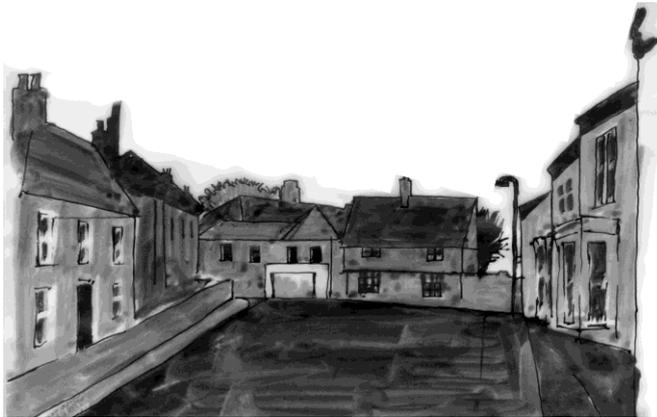
Left: View down Church Street to The High Street (left). This view shows the importance of nos. 2, 4 and 6 as a visual stop at the end of Church Street. The Shop front and the corrugated roof of no.2 are areas where significant enhancement could be made.

No.2 the High Street forms a good visual stop at the street's junction with the High Street and George Street, which would be greatly improved if the roof, presently corrugated, had thatch reinstated. Also at this point, much of the character of nos. 4 and 6 High Street has been lost through an unsympathetic shop front which cuts across the frontages of these properties. Any future scheme for remodelling should redress this. An aspect of Willingham which should be preserved is the good variety of shops present in the village. This all too often vanishing aspect of villages imparts a sense of community and identity.

- High Street
No 2. House, c1600. Timber framed, roughcast and pebbledash rendered with steeply pitched roof now covered with asbestos. Two bay, lobby entry plan. Two storeys with first floor jettied to road. Two casements at first floor and two hung sashes on either side of doorway with c1840 reeded doorcase with boss enrichments at corners. The gable end to the right hand has the date 1756 applied to the pebbledash. Listed grade II.

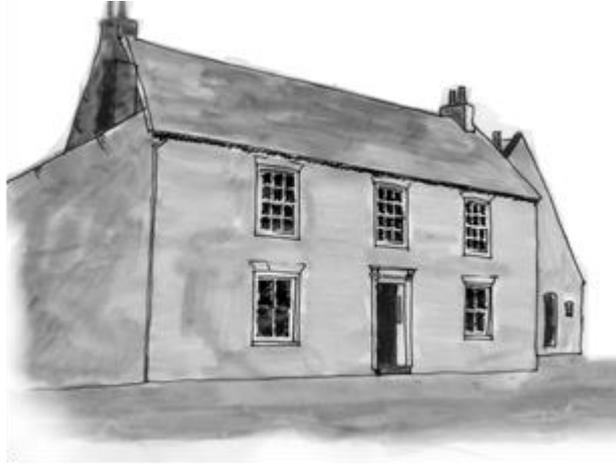
Above: No. 60 The Homestead. (above) Good C18/19 three bayed house with parapet gables, largely intact. Gault brick English bond to the rear wall with some red brick particularly to gable ends. Tiled roof, steeply pitched, with dentil eaves. Central doorway with doorcase of plain pilasters and narrow hood on moulded scroll brackets. To left hand is a horseman's cottage, now a kitchen. Gault brick front wall but side walls and stack are of earlier red brick. Listed Grade II.

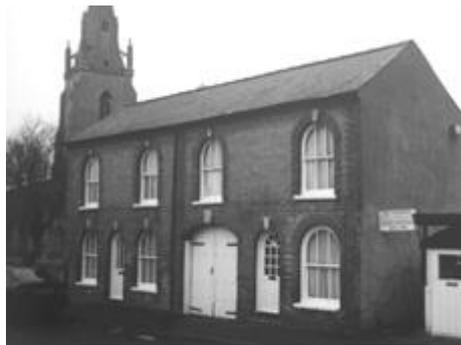
(Below) Nos. 19 & 21 - A pair of unusual C19 brick houses with semi-circular arched headers.

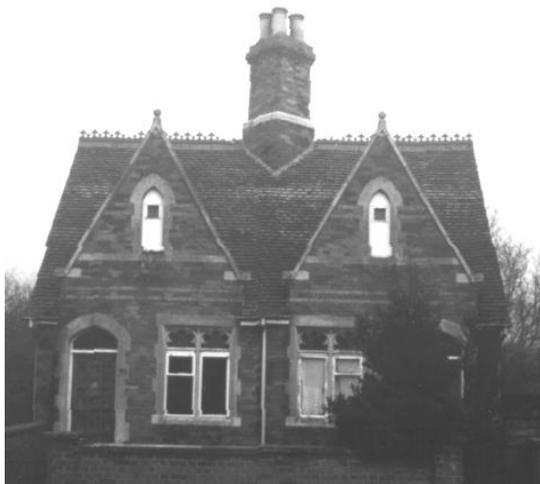
Nos.43 & 45 Church Street. A pair of Gothic Revival almshouses.

- Barn to the Rear. Barn, C17. Timber framed, with a corrugated iron. Has been converted to a house. Listed grade II.
- Nos.43 & 45. A pair of C19 Gothic Revival almshouses. A very unusual and picturesque addition to the street scene. Unlisted.
