## Appendix 2: Heydon's non-designated heritage assets

## Introduction

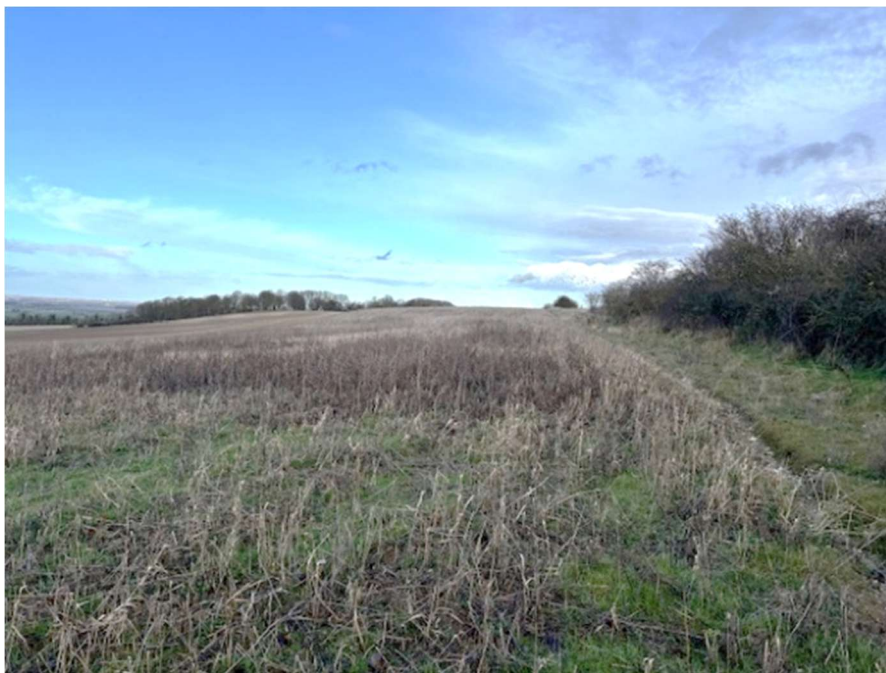
Image 1: Strip lynchets on Anthony Hill

**Description:** Strip lynchets are features of ancient fields systems, they are banks of earth that have built up on the downslope of a field ploughed over a long period of time.

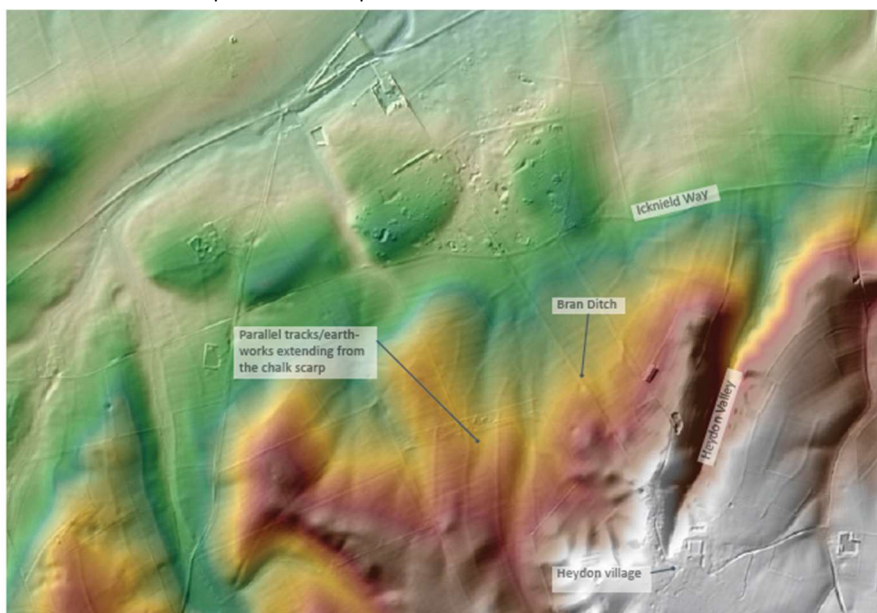
Image 2: LIDAR mapping with annotations, extracted from HLA 2022

**Description:** LIDAR indicates a series of linear earthworks/routes that cut across the landscape west of Bran Ditch and that are likely to be pre-historic in origin. The HLA 2022 p4 observes that they reflect the importance of the open chalk slopes between the top of the chalk ridge and the Icknield Way and that 'the area is especially valuable as a historic landscape with significant potential to reveal evidence from the prehistoric period'. (See CHER 11449)

LIDAR mapping showing parallel tracks/earthworks extending from the chalk scarp

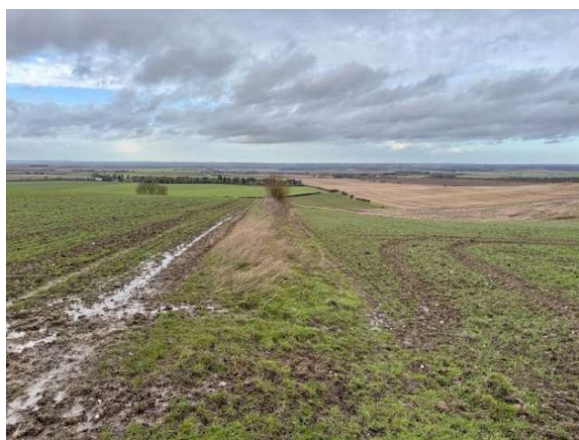
Image 3: linear earthworks west of Bran Ditch

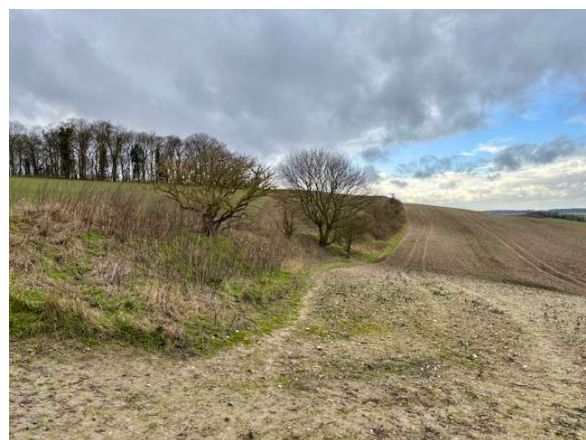
Image 4: linear earthworks on Chishill Down, west of Bran Ditch

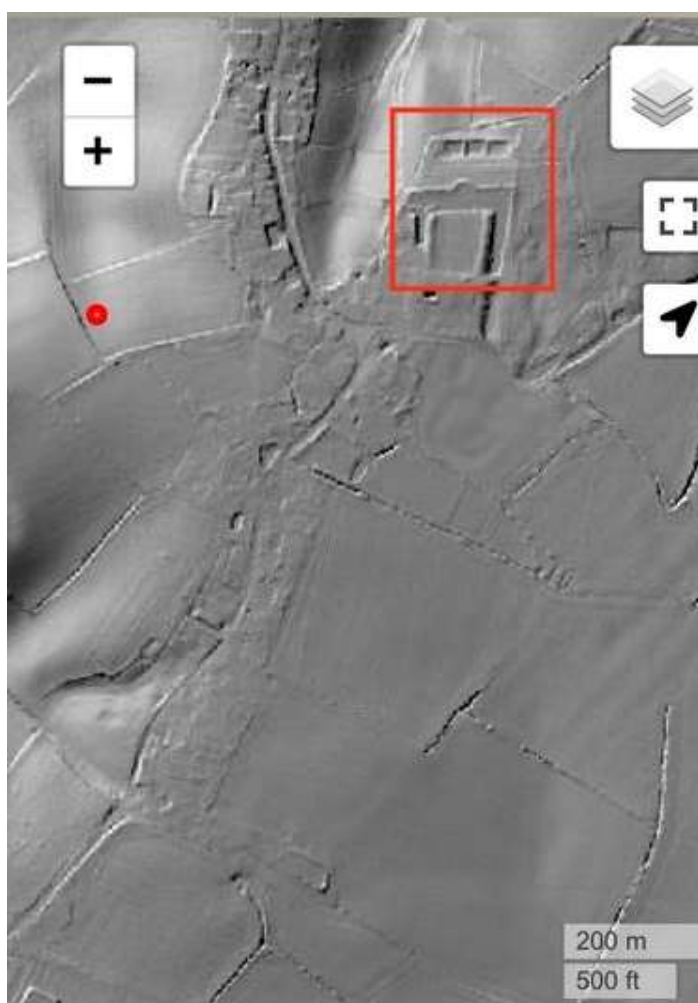
**Description:** The moated site is thought to date to the 13<sup>th</sup>C and a Tudor manor house on the site was replaced in 1820 by the present day Heydon House (known today as Heydonbury). The Tudor mansion stood within the three-sided moat which was later made part of a lake within the landscaped grounds. There are former rectilinear fishponds to the north (evident as earthworks today). The site is marked on the LIDAR image below. (See CHER 01261) [https://www.heritagegateway.org.uk/Gateway/Results\\_Single.aspx?uid=MCB1624&resourceID=1000](https://www.heritagegateway.org.uk/Gateway/Results_Single.aspx?uid=MCB1624&resourceID=1000)

Image 5 – Lidar image, fishponds and moat, Heydonbury

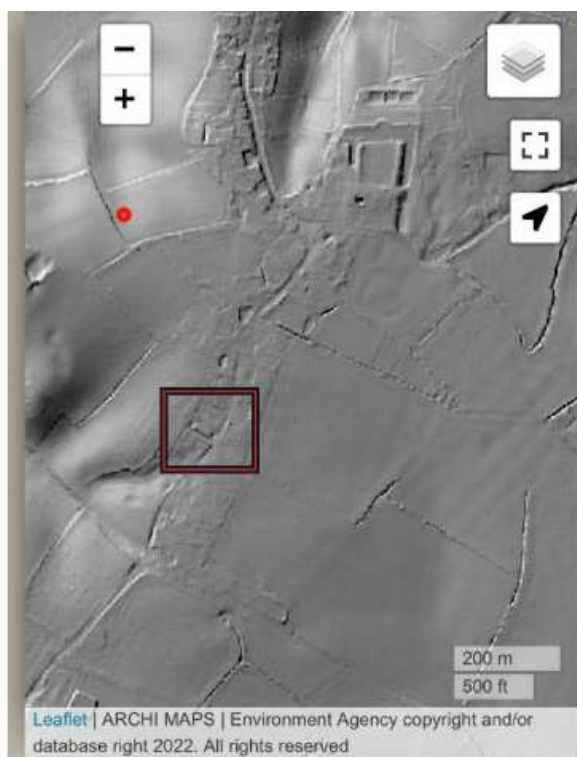
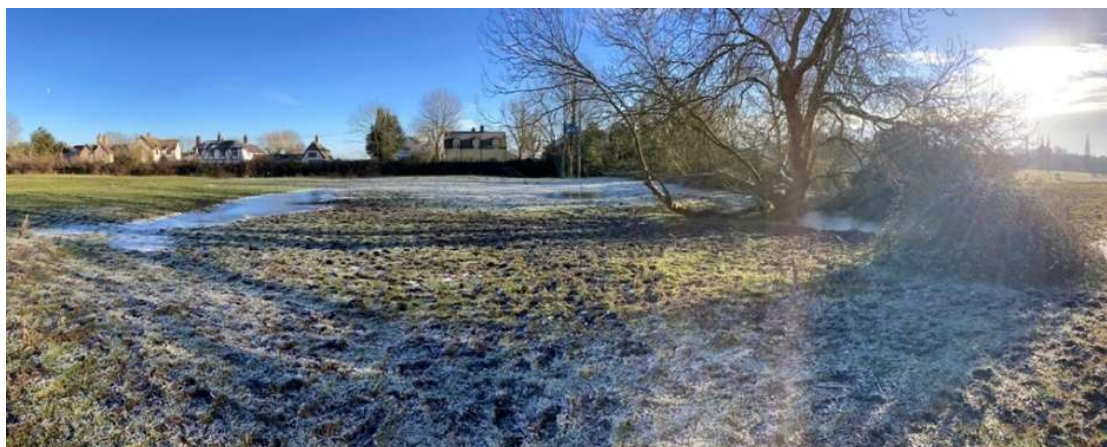
**Description:** Linear rectangular water feature in this location may have been a moated site. Earthworks are visible in this area on the LIDAR. The site is marked on the Lidar image below. (See MCB 19129)

Images 1 & 7: Lidar image and photograph of site of potential moated manor house, Chishill Road

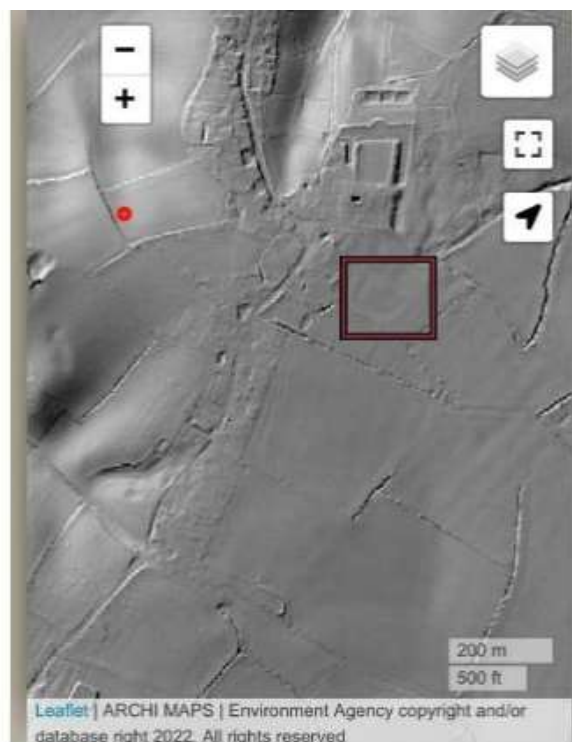
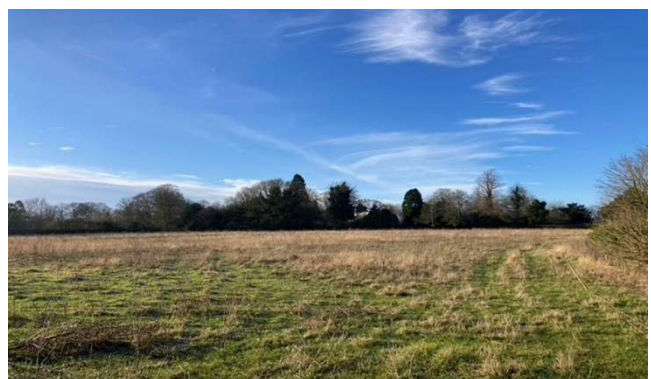
The moat is visible in aerial photographs and LIDAR.

Images 8 & 9: Lidar image and photograph of site of moated Earles 14<sup>th</sup>/17<sup>th</sup>C Manor House

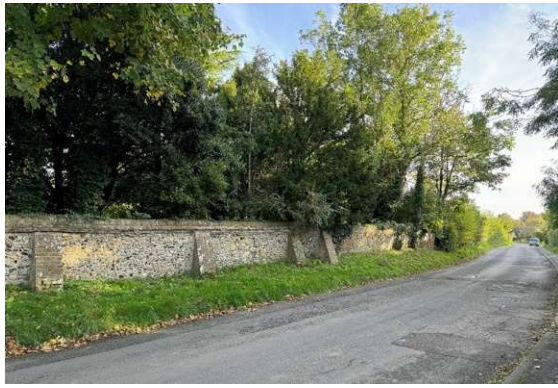
The flint walls are generally around 3-4 ft (0.9 – 1.2m) high and mark the boundaries of properties to the roadside. They consist of flint and lime panels with brick uprights and capping. Most date from the 19<sup>th</sup>C. Flint occurs naturally in the landscape and can be readily found in the field headlands as a result of ploughing.

Image 10: Flint walls, Heydonbury Farmhouse, Fowlmere Road (looking towards the village core)

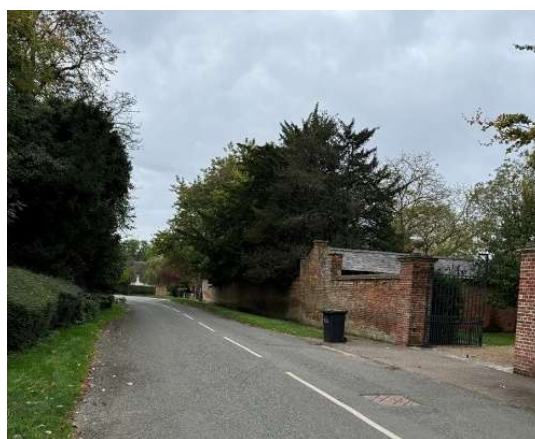
Image 19: Brick wall of the old walled garden, Bury House, Heydon Lane (looking towards the village green).

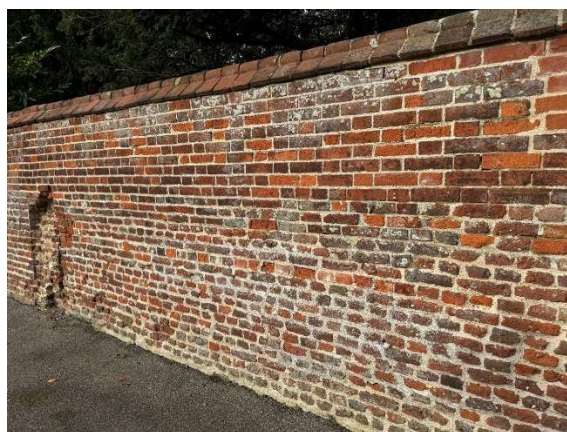
**Description:** There are 9 flint walls and 4 brick walls that are characteristic of the local area. Several of these walls amalgamate to produce a characteristic brick, or brick and flint style exemplifying the rural materials used. There is evidence of Old English Wall Bond and Flemish Bond in the brick wall at Heydonbury along Heydon Lane, probably dating to 16<sup>th</sup>C. The boundary wall to Church Field is for the most part 17<sup>th</sup> and 18<sup>th</sup>C (CHER 05331a). In addition, there are flint frontages to the converted agricultural buildings on Fowlmere Road.

Image 21: Brick wall, Heydonbury, Heydon Lane, detail of older brick wall

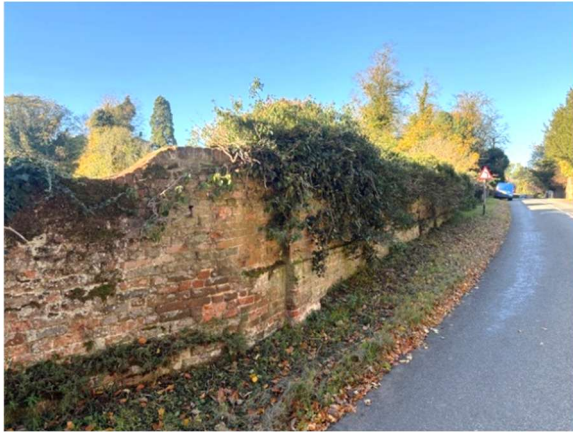
Image 24: Brick wall to churchyard and Church Field, Heydon Lane, showing the section heightened and treated with a dummy centre piece in the 19<sup>th</sup>C (CHER 05331a).

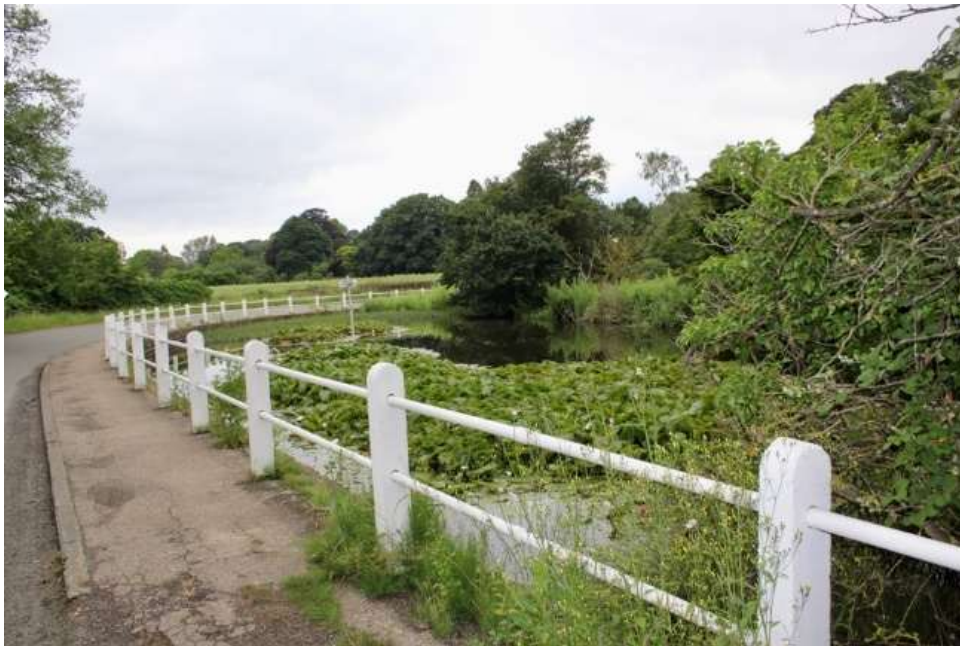
**Description:** Boundary treatment of white painted posts and rails.

Image 27: Spring Pond boundary treatment

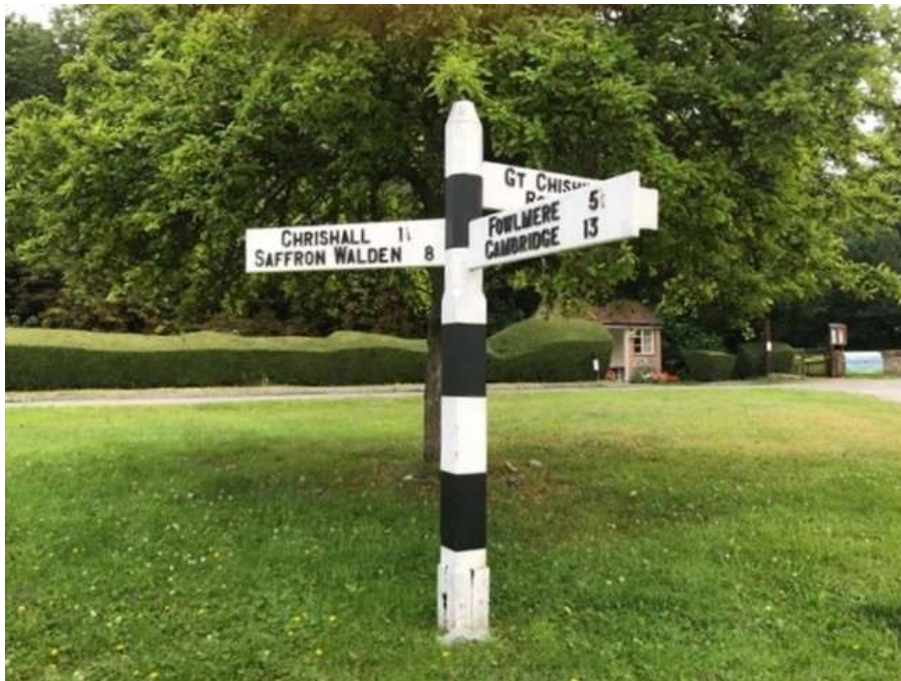
**Description:** A timber black and white painted traditional sign denoting directions to other villages

Image 29: Heydon Village finger post in village centre

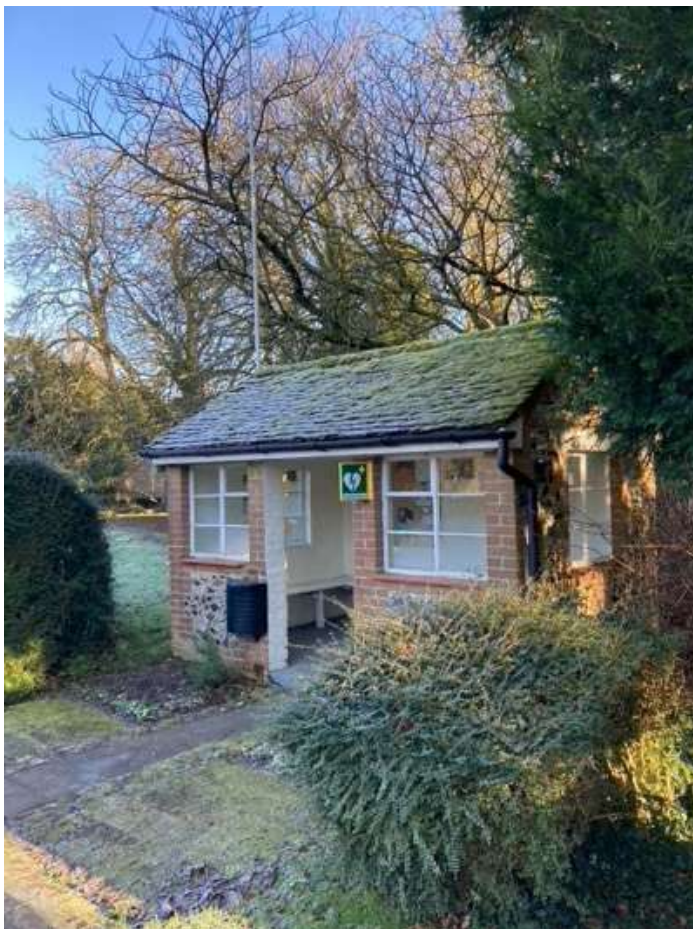
**Description:** A brick-built bus shelter, with clay tile roof, 'Crittall' style glazed windows and seating inside. The shelter is maintained and owned by Heydon Parish Council and is the location of a public notice board and the village defibrillator. It incorporates a flagpole which is often used to mark important dates and events.

Image 30: Bus shelter in Chishill Road

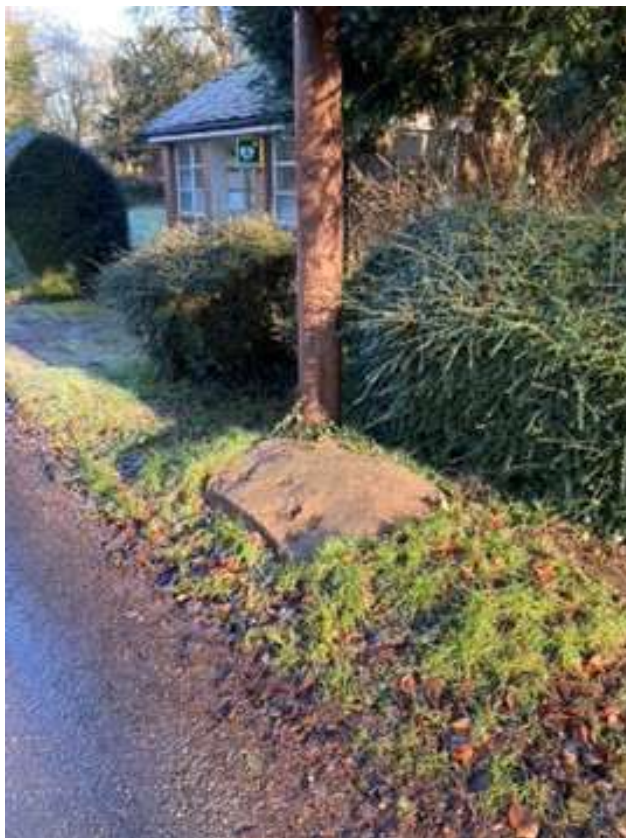
A very hard, natural rock called a 'silcrete', formed by the cementation of silica from sandstone that once existed above the Chalk. Sarsens are far more common further south so it may have been brought here by man or could have been moved by ice during the recent 'Ice Age'. It may even be a remnant of sandstones that once covered the local area. It, and the other sarsens present in the village, add to the local geodiversity.

Image 31: The Sarsen Stone
